Vario Roof R171 Troubleshooting Tree

Noise, leaktightness, fit and function analyses as well as important repairs including related damage codes (SSL) and chassis numbers (VIN).

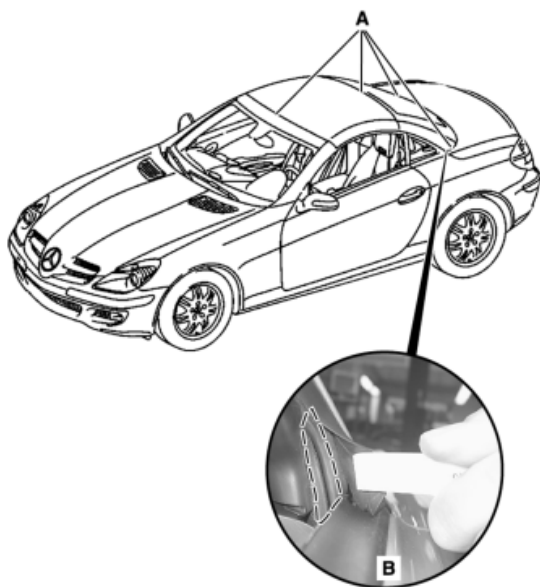
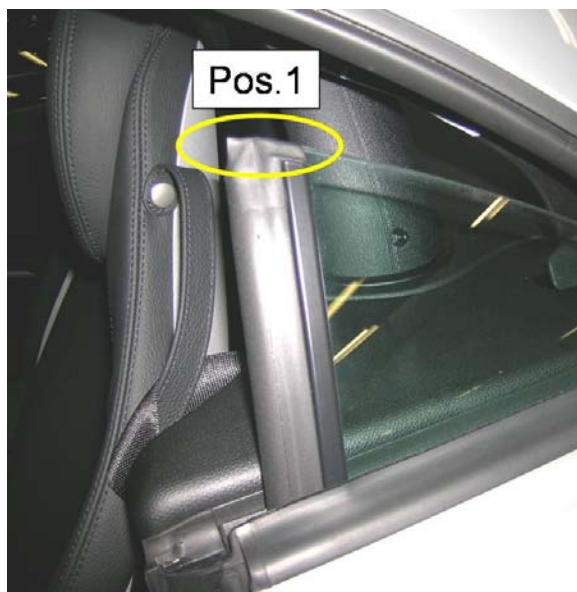
1.2.1 Noises on the Vario roof seals while driving

Complaint: Ripping/friction noises on all the Vario roof seals while driving.

Cause: Dry, dirty seals on the Vario roof are the most common cause for cracking and ripping noises while driving.

Measure: Treat the seals on the Vario roof and the bar seal on the upper rear side window (pos. 1) with a special antifriction agent, part no. A 001 989 50 51 or A 000 989 36 60, see AF77.30-P-1501AG.

Note: Observe the soaking time of the special antifriction agent.

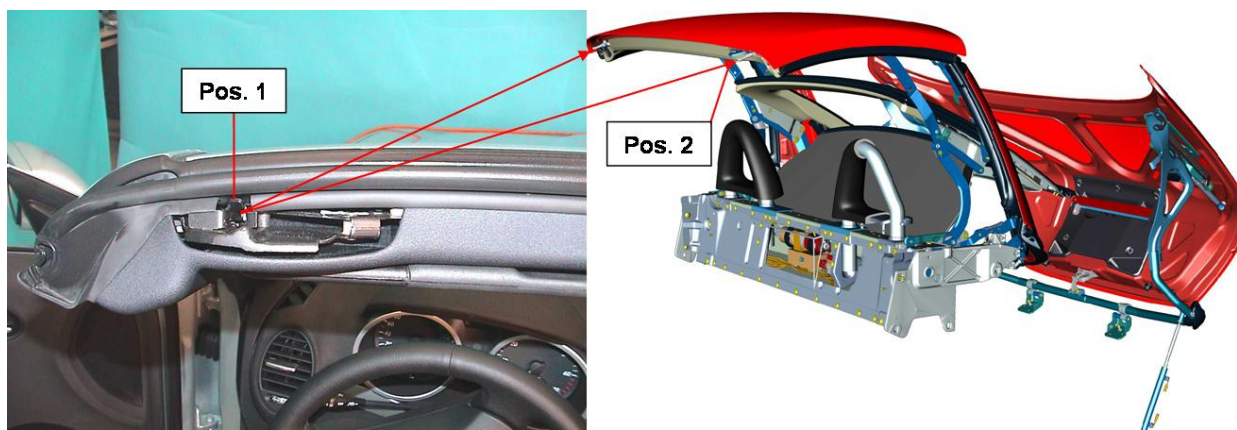
1.2.2.1 Rattling noises in the front Vario roof lock area

Complaint: Rattling noises in the front Vario roof lock support when driving on rough roads.

Cause: Funnel opening of the support (pos. 1) can be too large for the locking pin (pos. 2). As a result, noises may occur in the front Vario roof area when driving on rough roads.

Measure: See GI77.33-P-035782.

Important: Do not replace the complete front Vario roof lock.

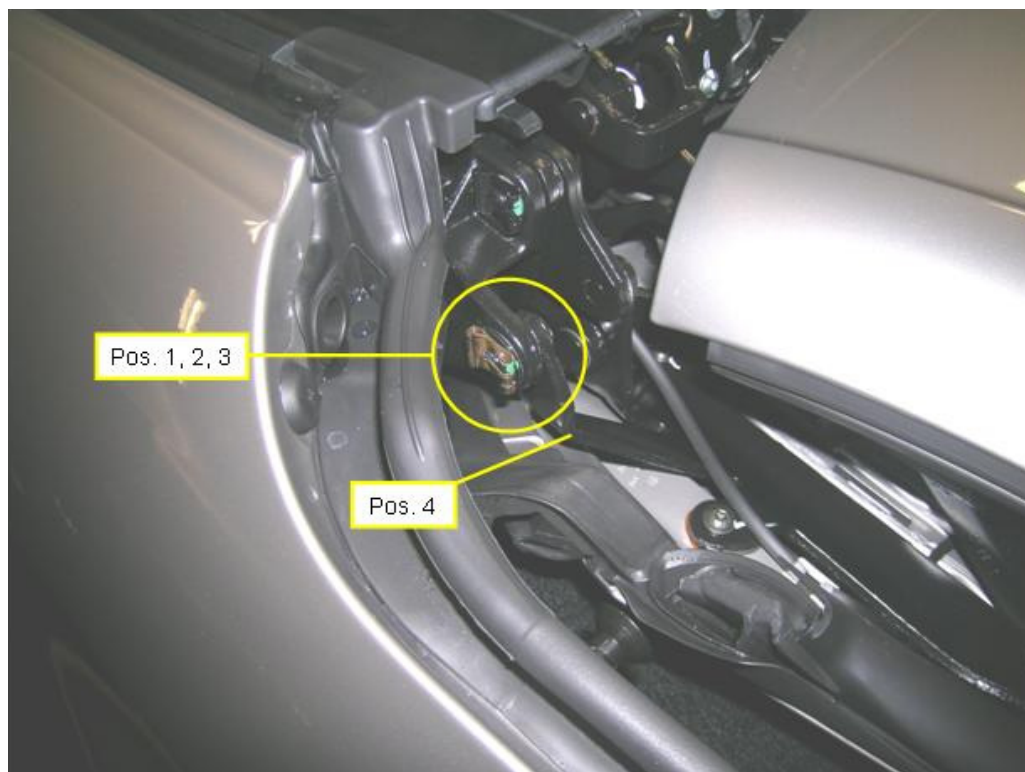
1.2.3.1 Cracking noises in the pivot 1 area on the roof frame

Complaint: Cracking noises in the pivot 1 area on the roof frame.

Cause: Washer and safety clip at pivot point 1 stuck together.

Measure: Remove safety clip and washer (pos. 1, 2). Clean the contact surfaces of the safety clip, washers and roof frame and afterwards grease with low-friction paste, part no. A 001 989 46 51. Press the handle (pos. 4) a bit to the inside and grease the pin (pos. 3) on pivot 1 with low-friction paste, see GI77.33-P-036569.

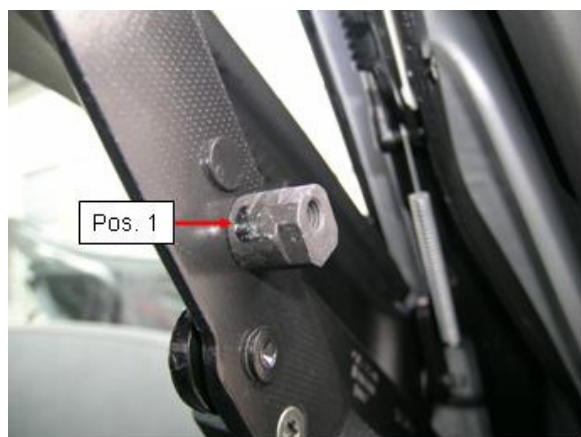
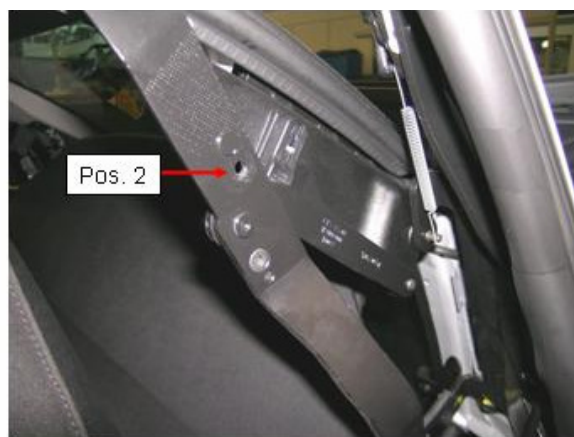
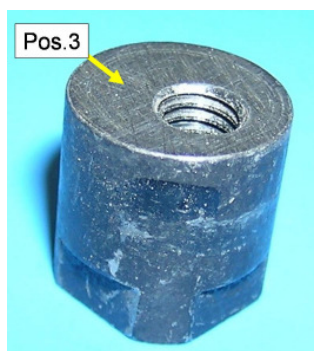
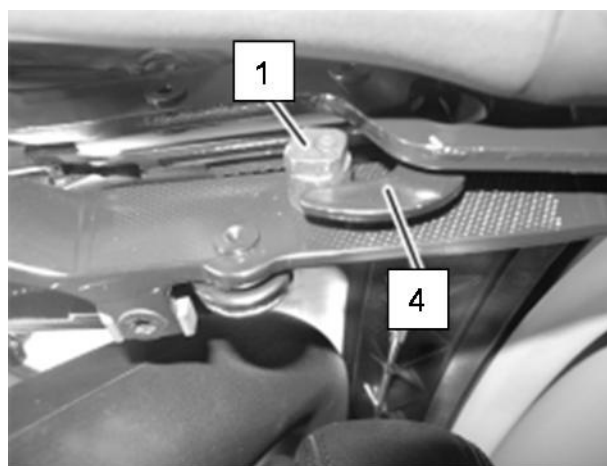
1.2.3.2 Cracking noises (knocking) in the eccentric area on the roof frame

Complaint: Cracking noises while driving.

Cause: Eccentric is loose since:
1. Contact surface of the countersunk bolt in the roof frame is too small.
2. Contact surface of the eccentric to the roof frame is painted.

Measure: 1. Only if the eccentric is loose:
Remove eccentric (pos. 1), drill bore (pos. 2) in the handle (6.2 mm), apply corrosion protection (briefcase black) in the bore, see GI77.33-P-032755.

Remove paint from the contact surface (pos. 3) of the eccentric.

Install and adjust eccentric again, see AR77.33-P-3475V, ensure correct position of the gate valve (pos. 4) in the locked Vario roof.

2. For fixed eccentric with rattling noises – adjust gate valve, see AR77.33-P-3475V.

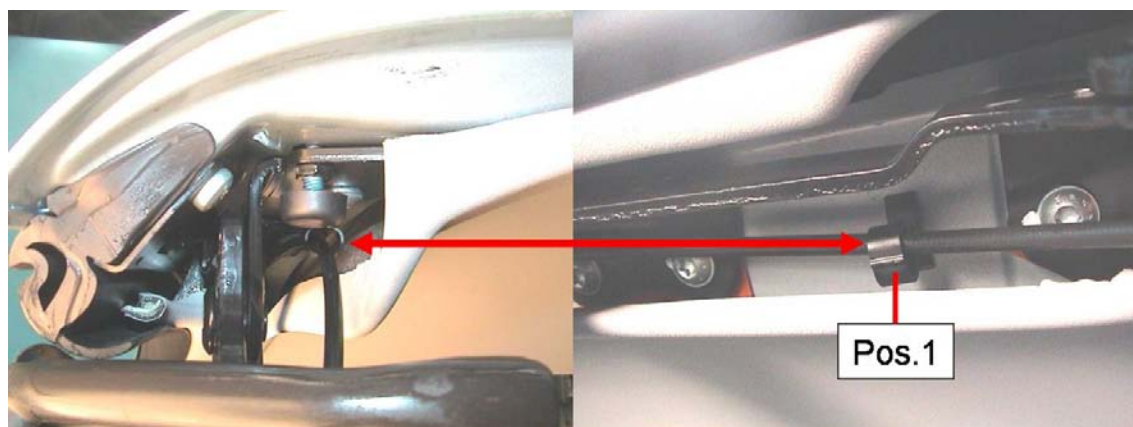
1.2.3.3 Ripping noises in the Bowden cable joint 2 area

Complaint: Fine ripping noises in the Bowden cable joint 2 area.

Measure: Replace omega clips (pos. 1) (with short foot), part no. A 000 995 54 44.

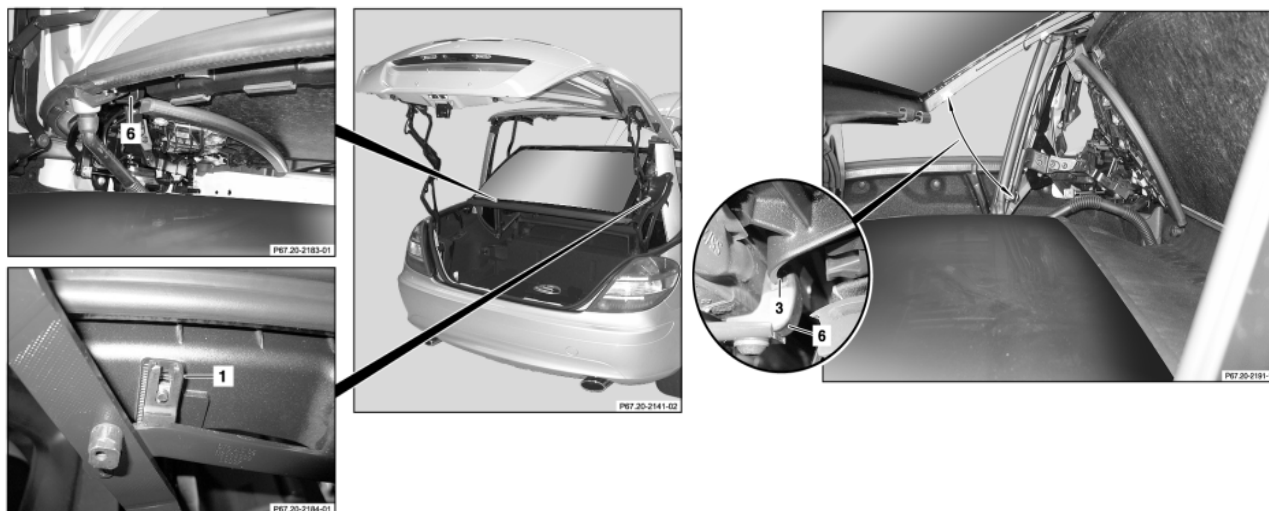
1.2.3.4 Noises in the Y-Z fixing stop area

Complaint: Noises in the Y-Z fixing stop area of the upper/lower rear window.

Cause: 1. Adjustment of the stops is not OK.
2. Stops not/insufficiently greased.

Measure: Check the position of the rear window, if necessary adjust, see AR67.20-P-3002V.
Grease rear window stops with (pos. 1 and 6) with low-friction paste, part no. A 001 989 46 51.

Note: When doing adjustment operations, bear in mind the fit of the rear window to the Vario roof.

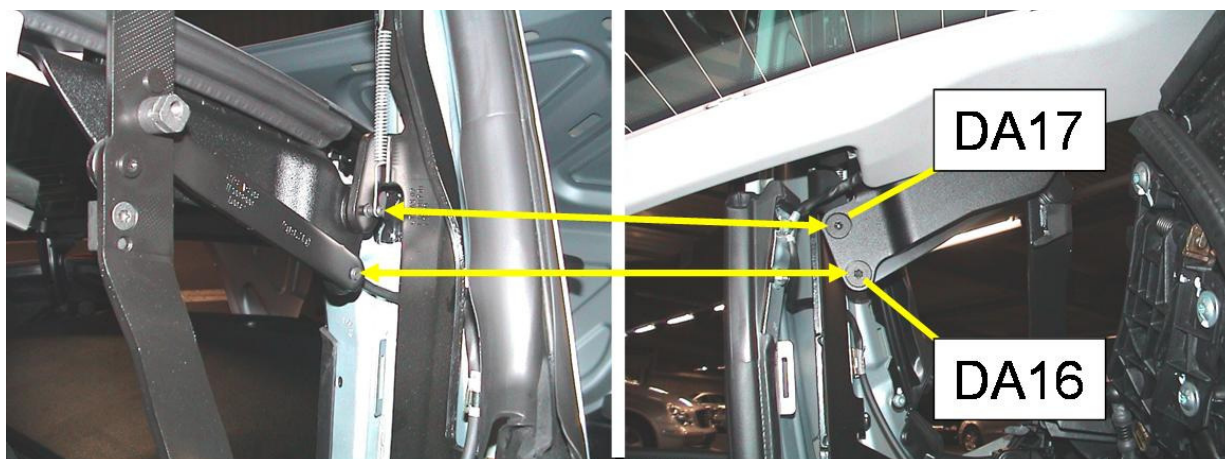
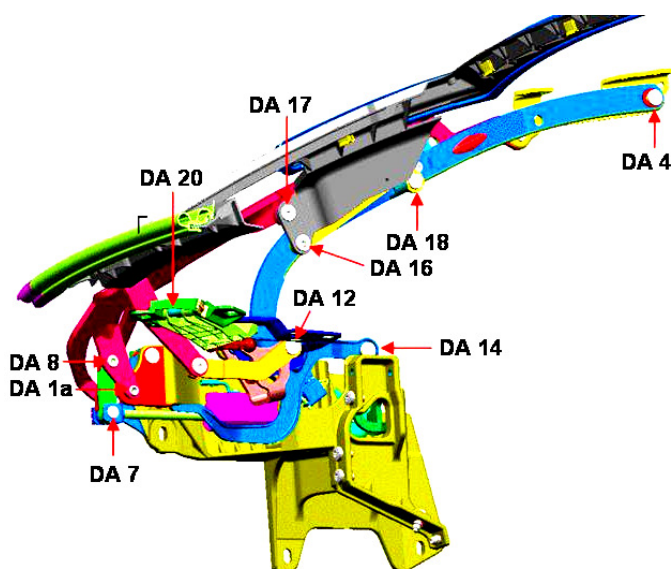
1.2.3.5 Noises in the rear window control linkage

Complaint: Ripping noise/crackling noise/cracking noise from the Vario roof C-pillar.

Cause: 1. Residues of thread lock paint and cataphoretic immersion primer in the bushings and between the pivots (DA16, DA17).

1. Remove screw completely at DA16.
Note: When removing the screw, pay attention to the washer on the pivot.
Clean the bushing, remove the residues of thread lock and cataphoretic immersion primer and turn in and tighten the screw with thread locking agent, part no.: A 003 989 31 71 (tightening torque 20 Nm).
2. Remove screw completely at DA17.
Note: When removing the screw, pay attention to the washer on the pivot.
Clean the bushing, remove the residues of thread lock and cataphoretic immersion primer and turn in and tighten the screw with thread locking agent, part no.: A 003 989 31 71 (tightening torque 20 Nm).

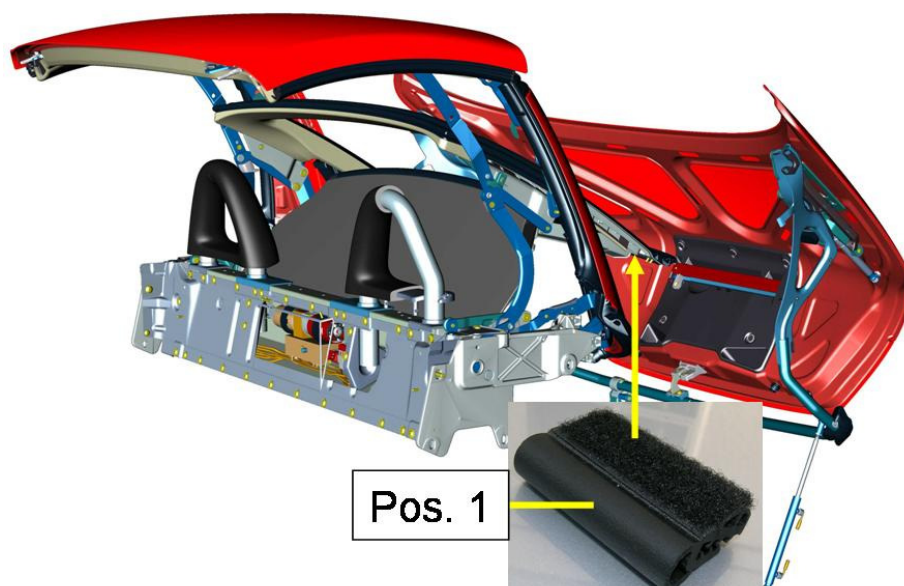
1.2.4.1 Noises (thumping) in the rear shelf area of the lower rear window

Complaint: Noises (thumping) in the rear shelf area of the lower rear window while driving.

Cause: Insufficient pre-tension of the rear shelf to the rear window frame.

Measure: Install damping material, part no. A 171 694 00 92, with fleece tape (pos. 1). Fasten damping material to the rear window frame with superglue. Parts were modified while retaining the previous part no.

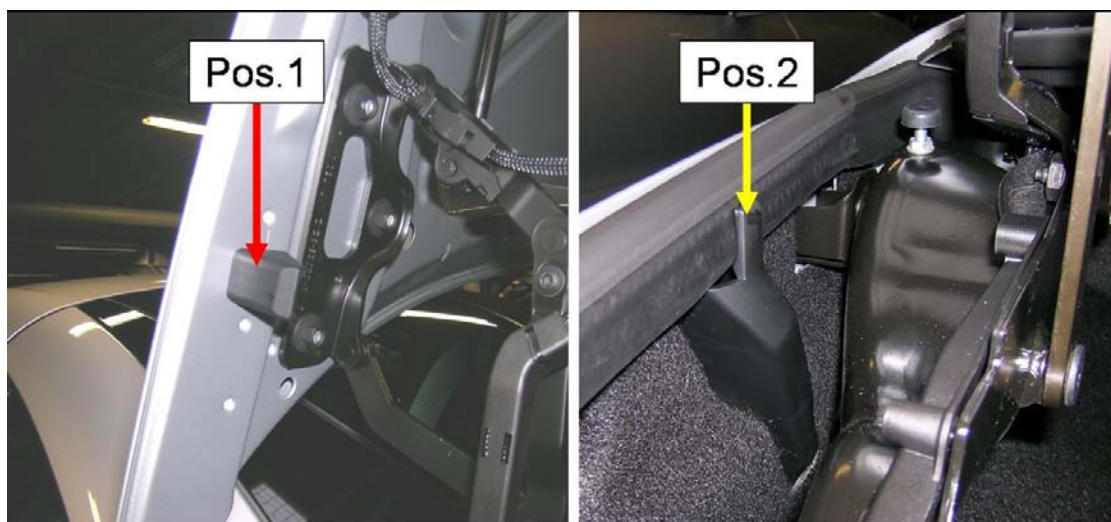
1.2.4.2 Noises in the trunk lid area

Complaint: Noises when cornering or on rough roads

Cause: Stops on the side of the trunk lid (pos. 1) cause ripping/friction noises if fitted too tightly.

Measure: 1. Adjust stops (pos. 1) in such a way that they rest against the fixings (pos. 2) when the trunk lid is closed, then push 1 mm to the outside (pre-tension) and tighten, see AR88.50-P-5200V.
2. Grease trunk lid guide (pos. 1) with low-friction paste, part no. A 001 989 46 51.

Note: Apply a thin coat of low-friction paste.
Always observe 1 mm pre-tension.

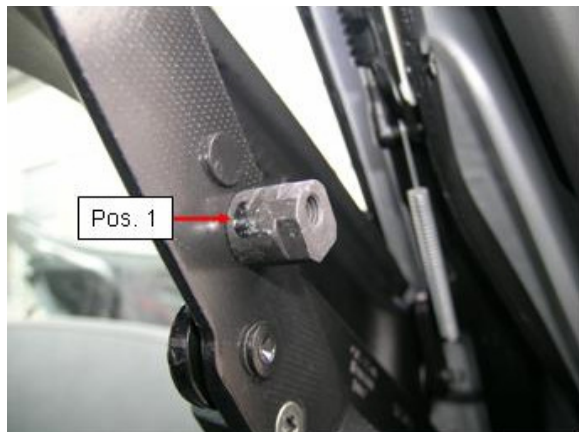
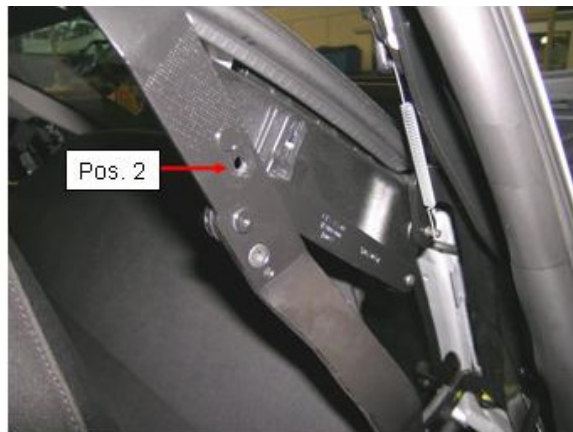
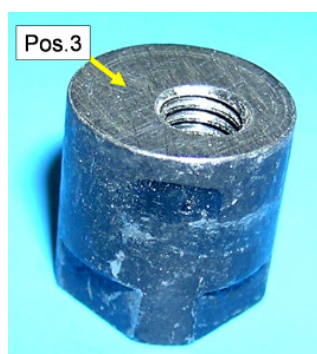
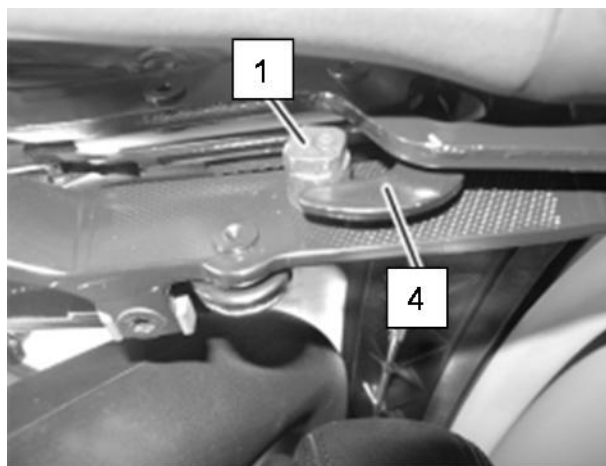
1.3.1 Wind noises in the front Vario roof joint area to the rear window

Complaint: Wind noises from approx. 140 km/h in the B/C pillar area.

Cause: Eccentric is loose

Measure: 1. Only if the eccentric is loose:
Remove eccentric (pos. 1), drill bore (pos. 2) in the handle (6.2 mm), apply corrosion protection (briefcase black) in the bore, see GI77.33-P-032755.

Remove paint on the contact surface (pos. 3) of the eccentric,

Install and adjust eccentric again, see AR77.33-P-3475V, ensure correct position of the gate valve (pos. 4) in the locked Vario roof.

2. For fixed eccentric with rattling noises – adjust gate valve,
see AR77.33-P-3475V, ensure the correct position of the gate valve (pos. 4) in the locked Vario roof.

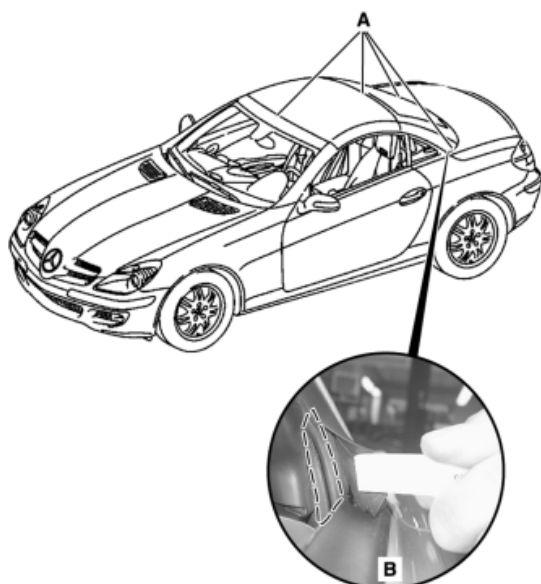
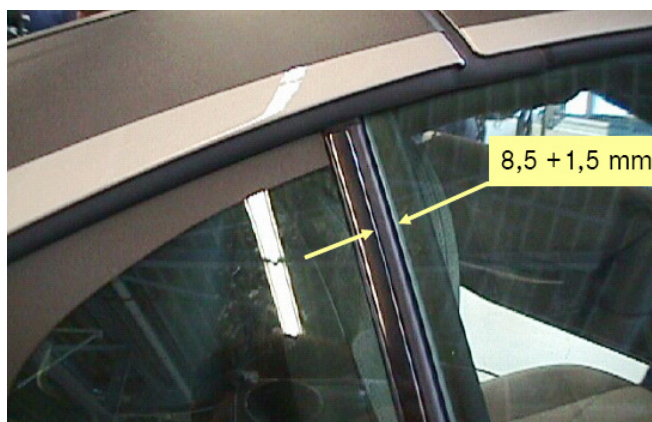
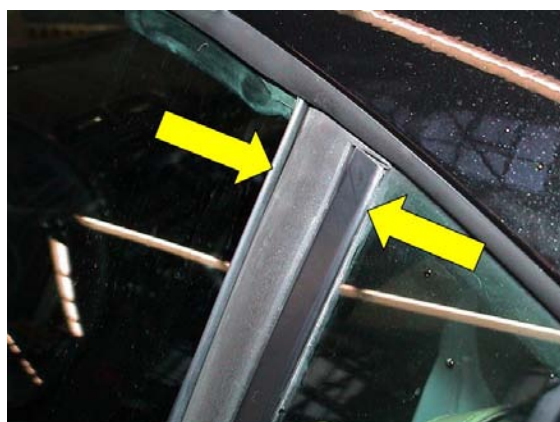
1.3.2.1 Wind noises in the side window/rear side window area

Complaint: Wind noises in the side window/rear side window area

Cause: Wedge-shaped gap in the bar seal area (B-pillar) between the side window and rear side window.
Adjustment of the rear side window is not OK.

Measure: 1. Treat the exterior C-pillar bottom seal with special antifriction agent, part no. A 001 989 50 51 or A 000 989 36 60, see AF77.30-P-1501AG.

Observe the soaking time of the special antifriction agent.

2. Adjust rear side window, see GI72.10-P-020305 Release 3.0.

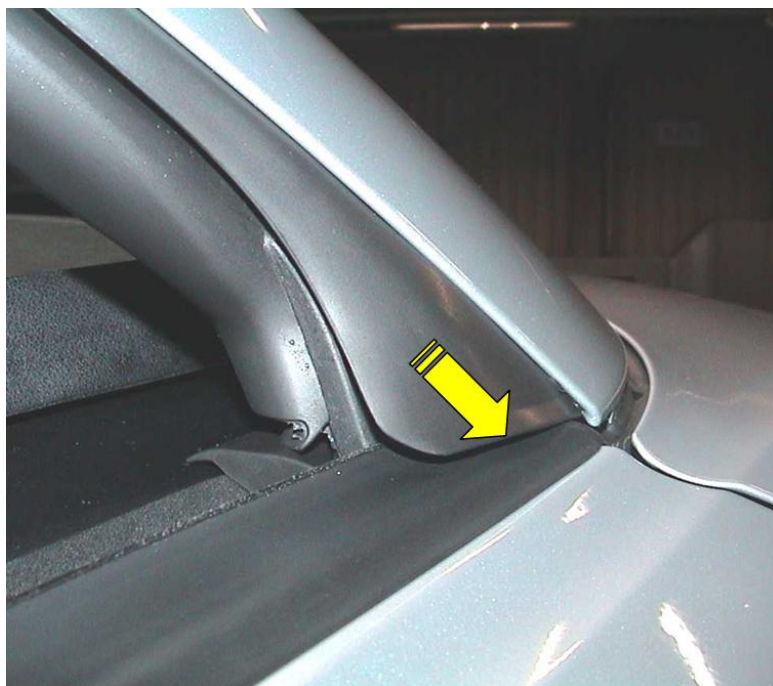
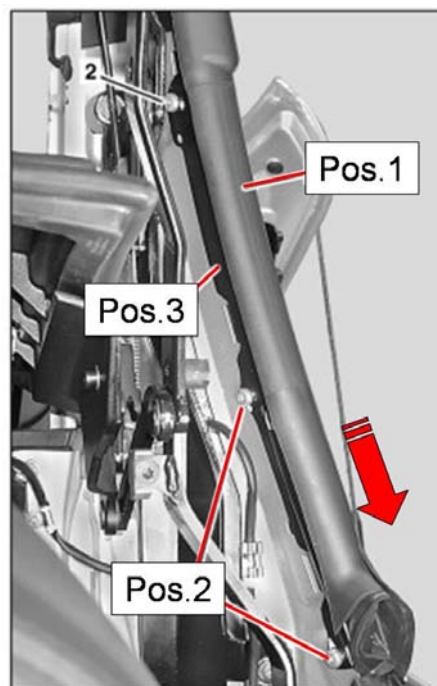
1.3.2.2 Wind noises in the side rear window/lower C-pillar area

Complaint: Wind noises from 80 km/h

Cause: Gap dimension (arrow) between exterior C-pillar seal and rear fender is too large.

Measure: Mount exterior C-pillar seal lower.

Note: Loosen only the lower screws (pos. 2) of the retaining rail (pos. 3) and pull the seal (pos. 1) lower. The seal can be pulled lower **up to 1.5 mm**. Do not pull it out of the retaining rail as there is a seal mass below the retaining rail and this could cause leakages, see AR77.50-P-6766V.

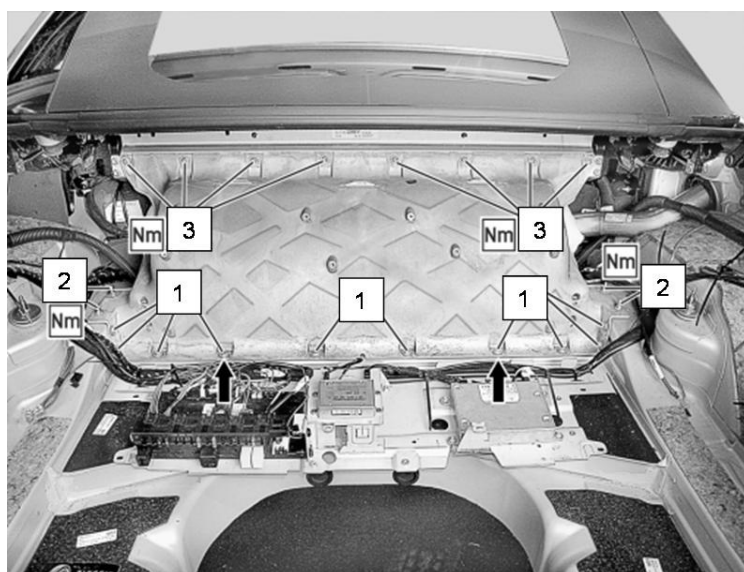
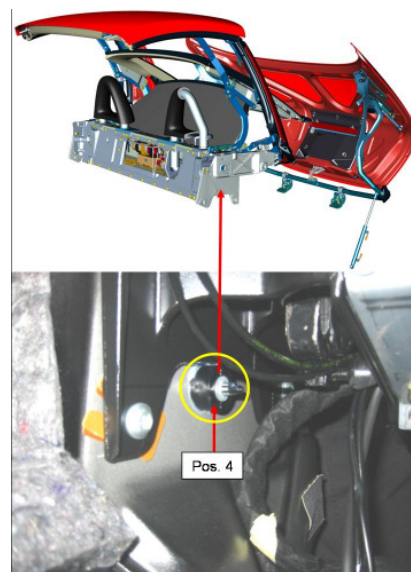
1.4.1 Cracking noises from the Vario roof trunk/C-pillar area

Complaint 1: Cracking/ripping noises from the trunk area.

Complaint 2: Cracking/ripping noises from the trunk area when the vehicle is started or braked sharply.

Cause 1: Decrease in torque of the threaded connections (pos. 1, 2) of the tank cover in the trunk.

Cause 2: Plastic spacer (pos.3) at stud support for Vario roof main bearing.

Note: This cracking noise can also be transmitted to the Vario roof C-pillar area and is, therefore, often assigned to the Vario roof.

Measure 1: Loosen all threaded connections and re-tighten them.
Tightening torque for the screws (pos. 1): 10 Nm
Tightening torque for the nuts (pos. 2): 6 Nm
Tightening torque for the screws (pos. 3): 6 Nm, see GI68.64-P-038163.

Recommendation: When handling the tank cover, the plastic spacer (pos. 4) should also be removed, see measure 2.

Note: If the tank cover does not rest on the longitudinal member, washers may have to be inserted in the screw connections (pos. 2). This prevents the studs from breaking off when being tightened.

Measure 2: Remove plastic spacer (pos. 3), to do so, remove trim on the left and right side in the trunk, see AR68.30-P-4800V.

Important: Do not loosen screws on the main bearing of the Vario roof.

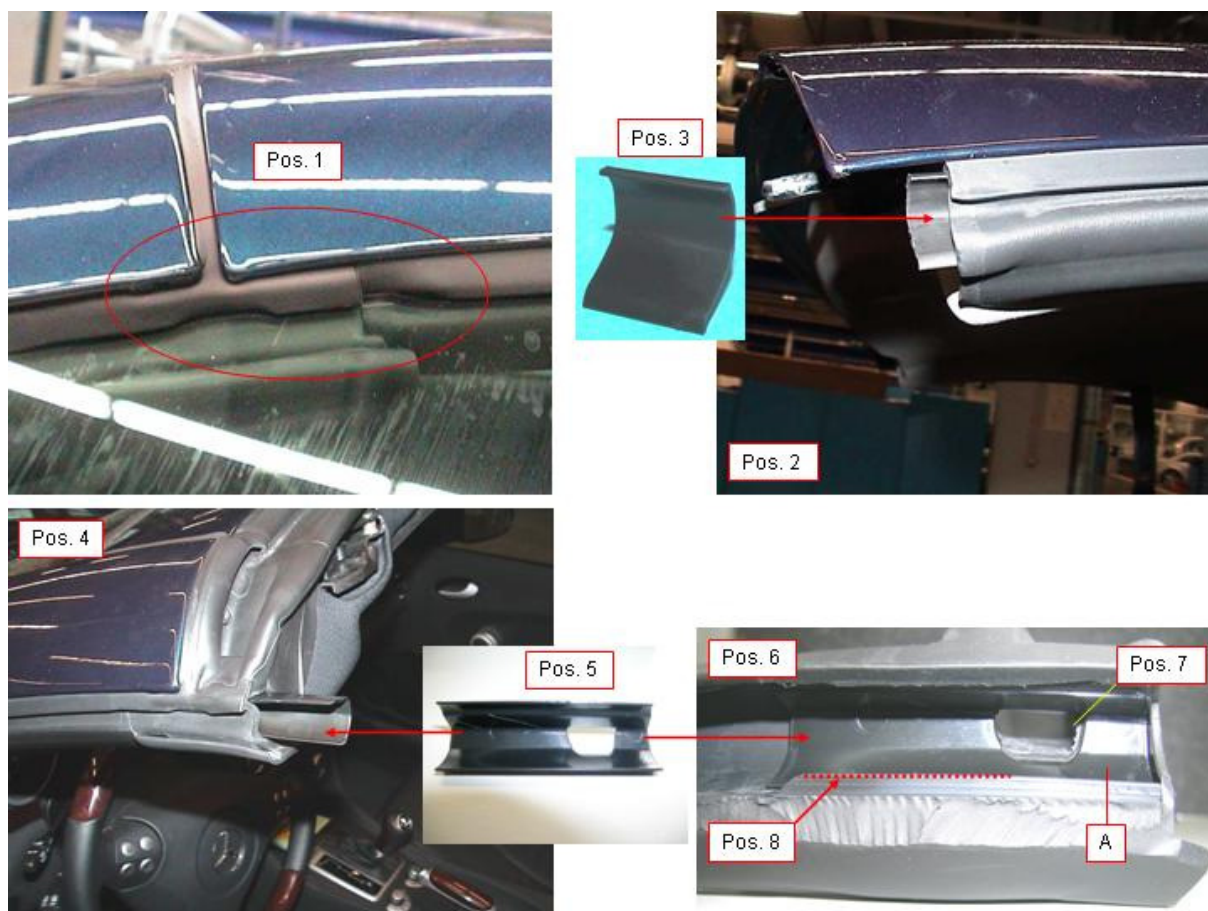
2.1.1 Seal at joint 1 buckled

Complaint: Buckled seal

Cause: 1. Insufficient return force and rigidity of the seals.
2. Window adjustment not OK.

Measure 1: Install clamps (pos. 5) with opening for water drain in the windshield frame seal (pos. 4) and a clamp (pos. 3) in the Vario roof front part seal (pos. 2), see GI77.30-P-012632.

Measure 2: Adjust side window, see GI72.10-P-020305 Release 3.0.

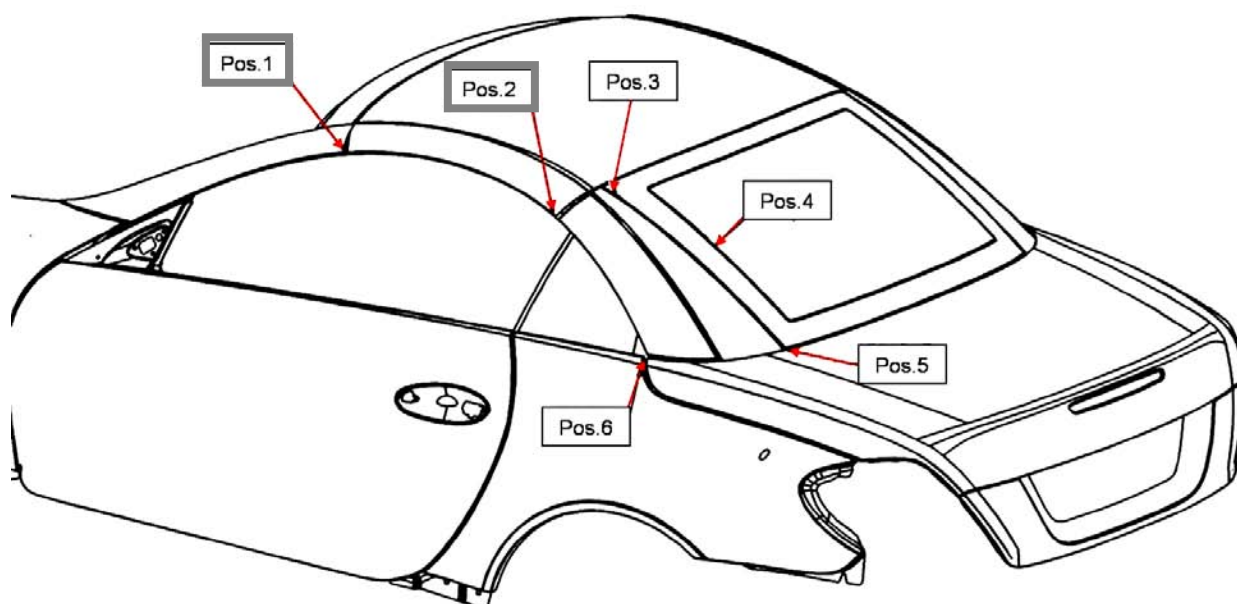
3.2.1 Water entry at joint 1/joint 2

Complaint: Joint 1 (pos. 1): 1. Water running down window 2. Water drips on the seat
Joint 2 (pos. 2): 1. Water running down window 2. Water on the B-pillar trim/rear trim behind seat

Cause: 1. Contact pressure too high/low = deformation/gap formation.
2. Window adjustment not OK.

Measure: 1. Adjust sealing, see AR 77.50-P-4200V.
2. Adjust rear window, see GI72.10-P-020305 Release 3.0.

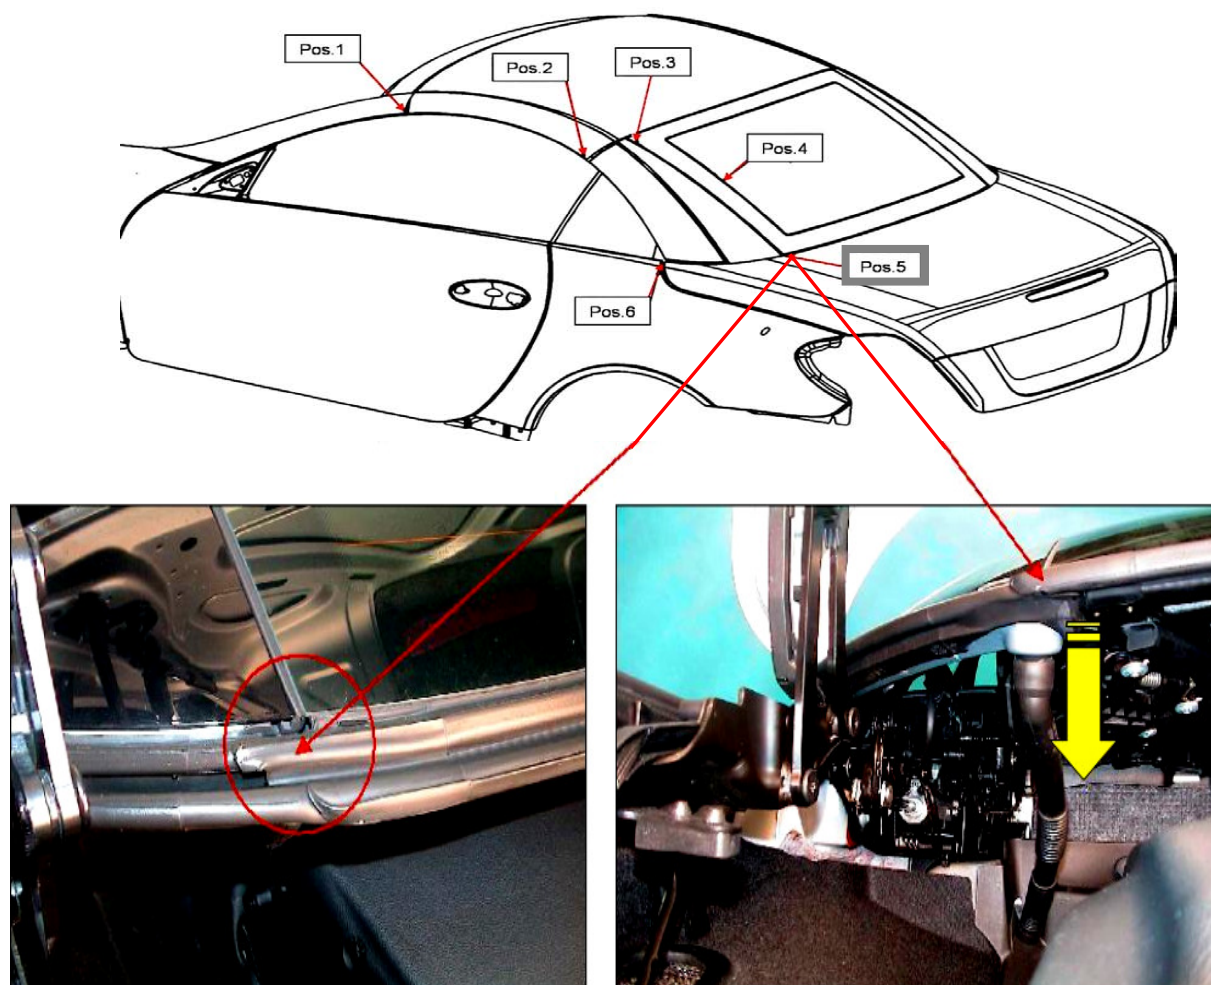
3.3.1 Water entry in the joint 5 area of the trunk

Complaint: Water near the luggage compartment partition.

Cause: 1. Sealing profile/sealing pad at the lower rear window seal is loose or not positioned correctly.

Measure: Glue new sealing pad onto joint 5, see GI77.30-P-018434.

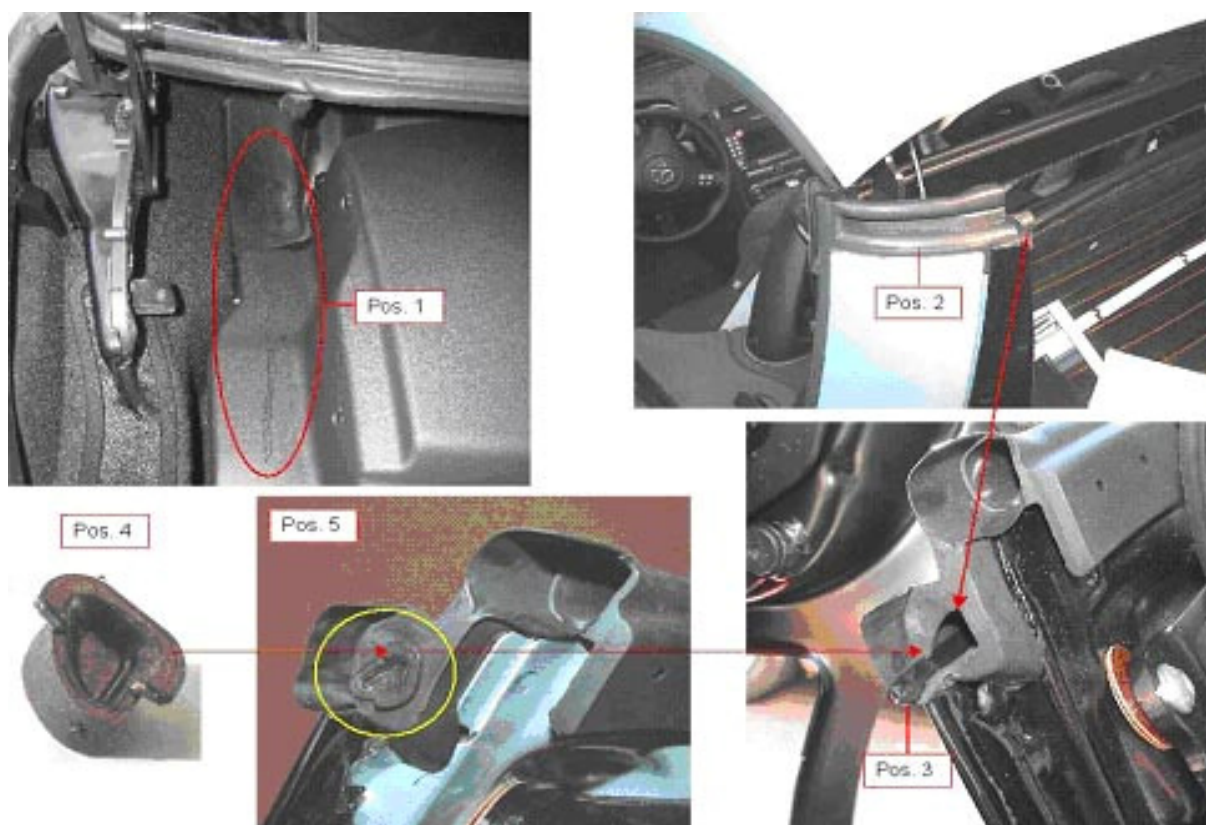
3.3.2 Water entry in the trunk on opening the Vario roof

Complaint: Water drips into the trunk on opening the Vario roof (pos. 1).

Cause: Seal plug missing in the upper C-pillar seal (pos. 4 and 5).

Measure: Glue sealing plug into the upper C-pillar seal, see GI77.30-P-012544.

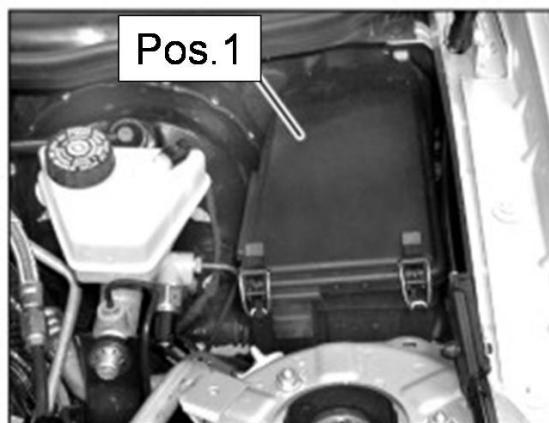
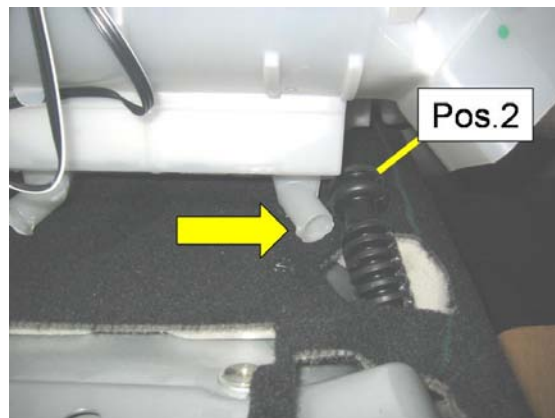
3.4.1 Water entry in the front footwell

Complaint: Moisture in the front footwell.

1. Cover of the fuse box (pos. 1) not closed properly.
2. Water drain hoses (pos. 2) not plugged to the air conditioning outlet in the footwell.
3. Water drain hose in the battery box clogged/no passage.

1. Check the cover of the fuse box and if necessary, close it.
2. Check if the water drain hoses are fitted properly and if required, plug correctly.
3. Check water drain hose and if necessary, clean the hose.
