Vario Roof R171 Troubleshooting Tree

Noise, leaktightness, fit and function analyses as well as important repairs including related damage codes (SSL) and chassis numbers (VIN).

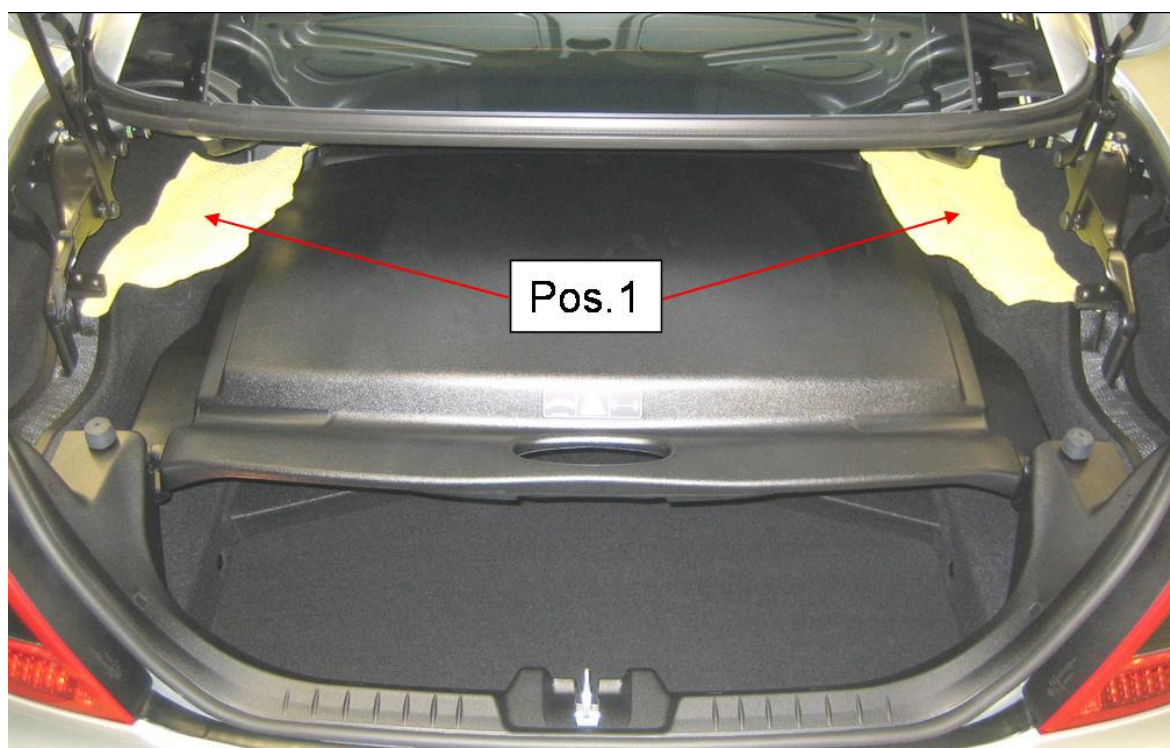
Location of the dry sponge cloths in the trunk

9. Check the cloths and localize the leakage.
10. In case of leakages, process the affected positions, otherwise proceed to step 12.
11. After processing the leakages, reshower the vehicle, duration: 20 min.

12. No water entry determined, reshower, duration 30 min.
Note: Some leakages can be determined only after a long reshower.
13. After viewing the sponge cloths, start again from step 9, if necessary.
